SUNRISE LAKE DAM
WAYNE COUNTY, MISSOURI

MISSOURI INVENTORY NO. 30043

PHASE I INSPECTION REPORT
NATIONAL DAM SAFETY PROGRAM

AUGUST 1978

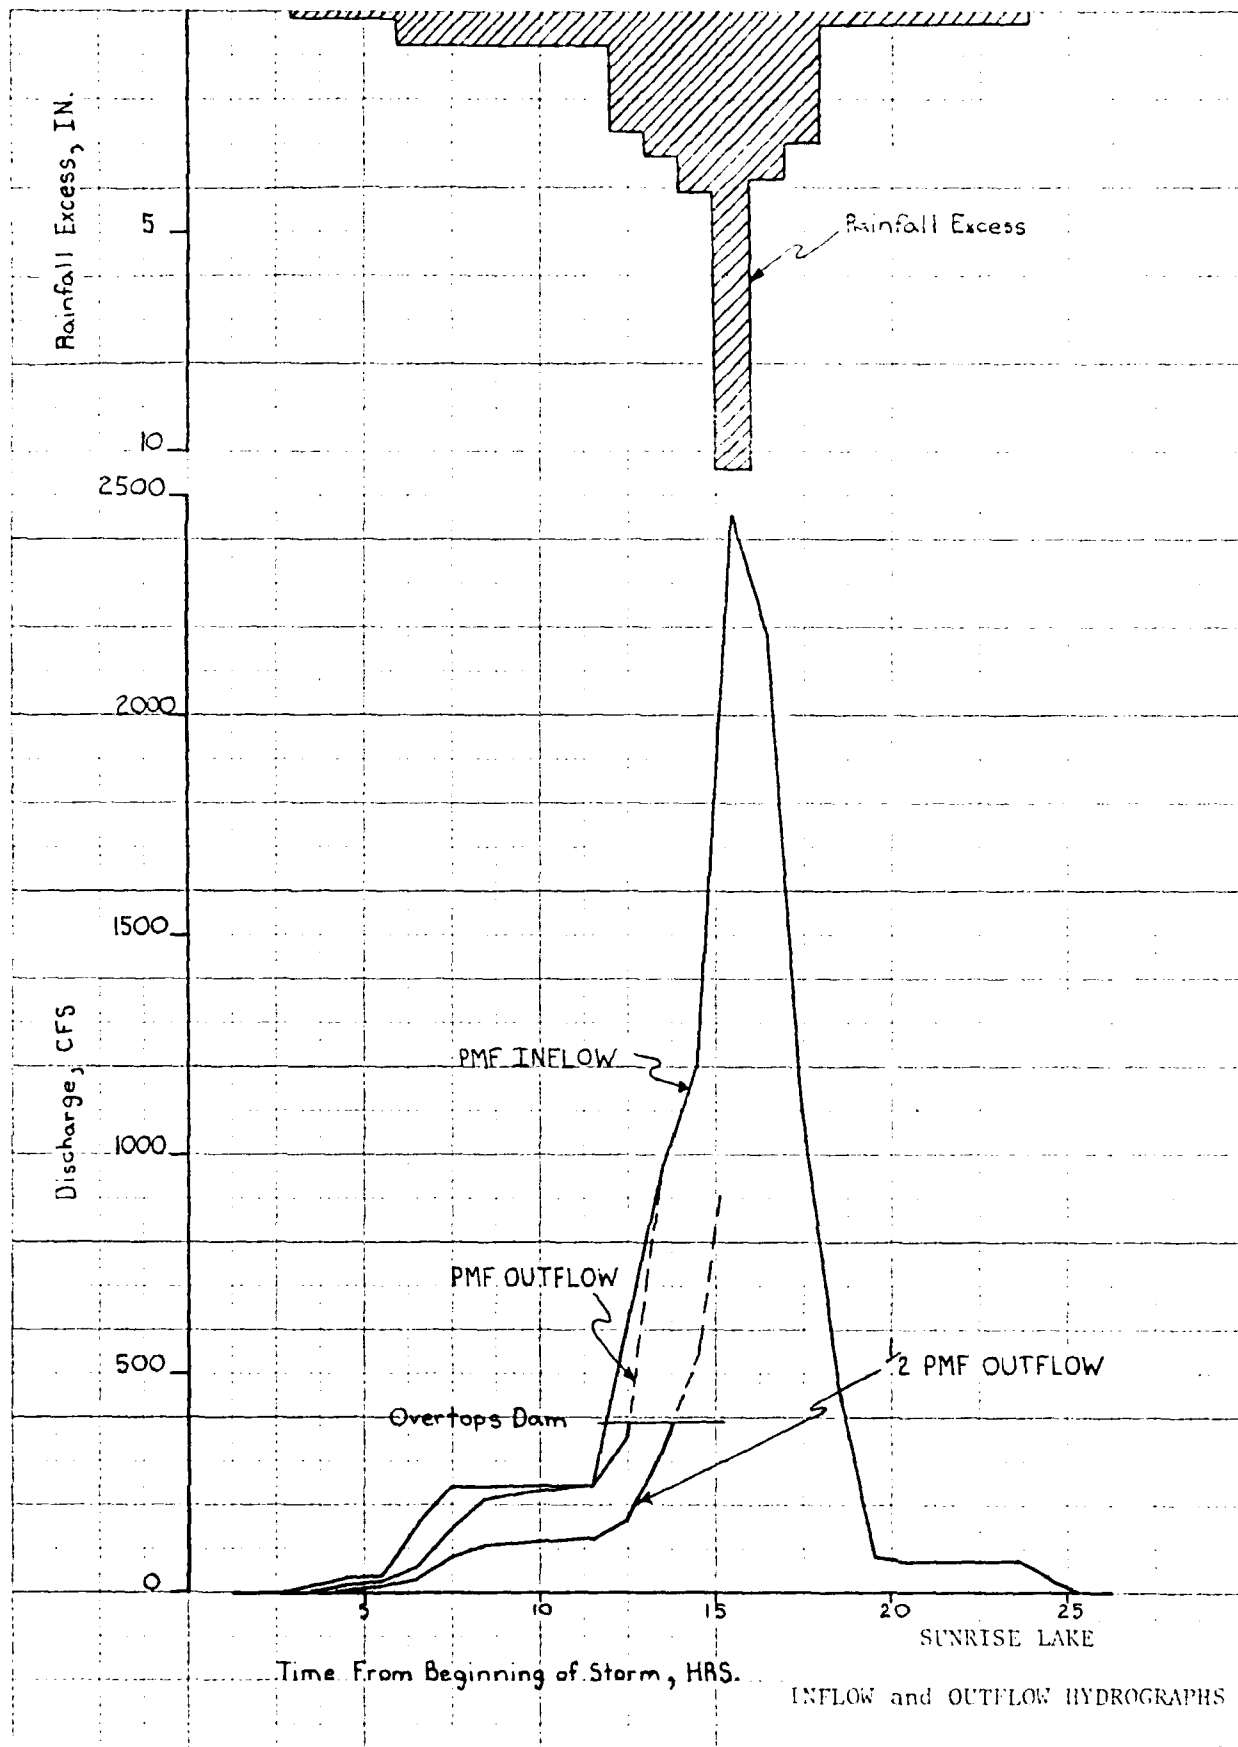
INFLOW and OUTFLOW HYDROGRAPHS

d. Overtopping Potential. The spillway will pass 15 percent of the Probable Maximum Flood (PMF), without overtopping the dam. The Probable Maximum Flood (PMF) is defined as the flood discharge that may be expected from the most severe combination of critical meteorologic and hydrologic conditions that are reasonably possible in the region. For its size and hazard category, this dam is required by the guidelines to pass from one-half PMF to PMF. However, considering the high hazard potential to life and property of approximately 3 families downstream of the dam, the spillway size and/or height of dam should be increased to pass the PMF, without overtopping the dam. Because the spillway will not pass one-half of the PMF without overtopping, the dam is classified as "unsafe non-emergency". The spillway will not pass the 100-year flood without overtopping, which is a flood that has a one percent chance of being exceeded in any given year.

a. Alternatives. Spillway size and/or height of dam should be increased to pass the Probable Maximum Flood without overtopping the dam.

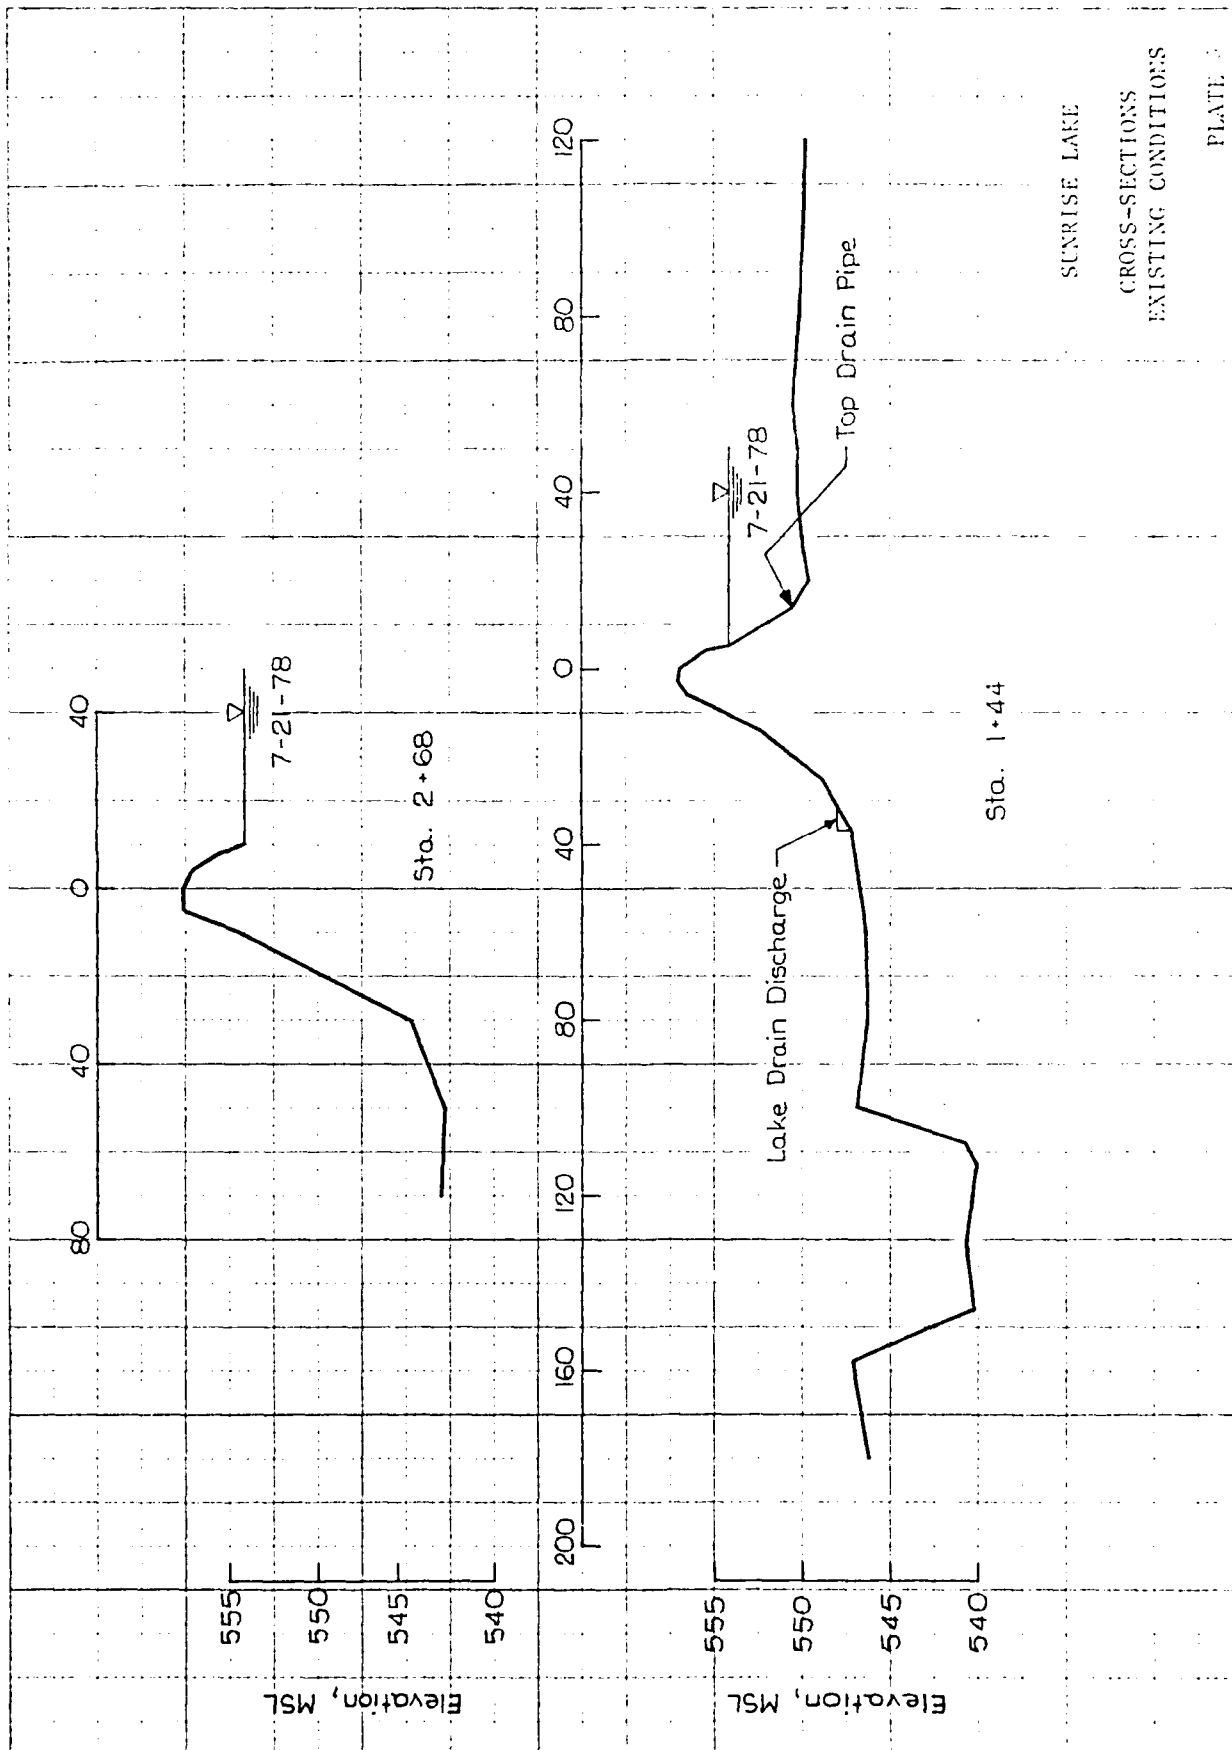
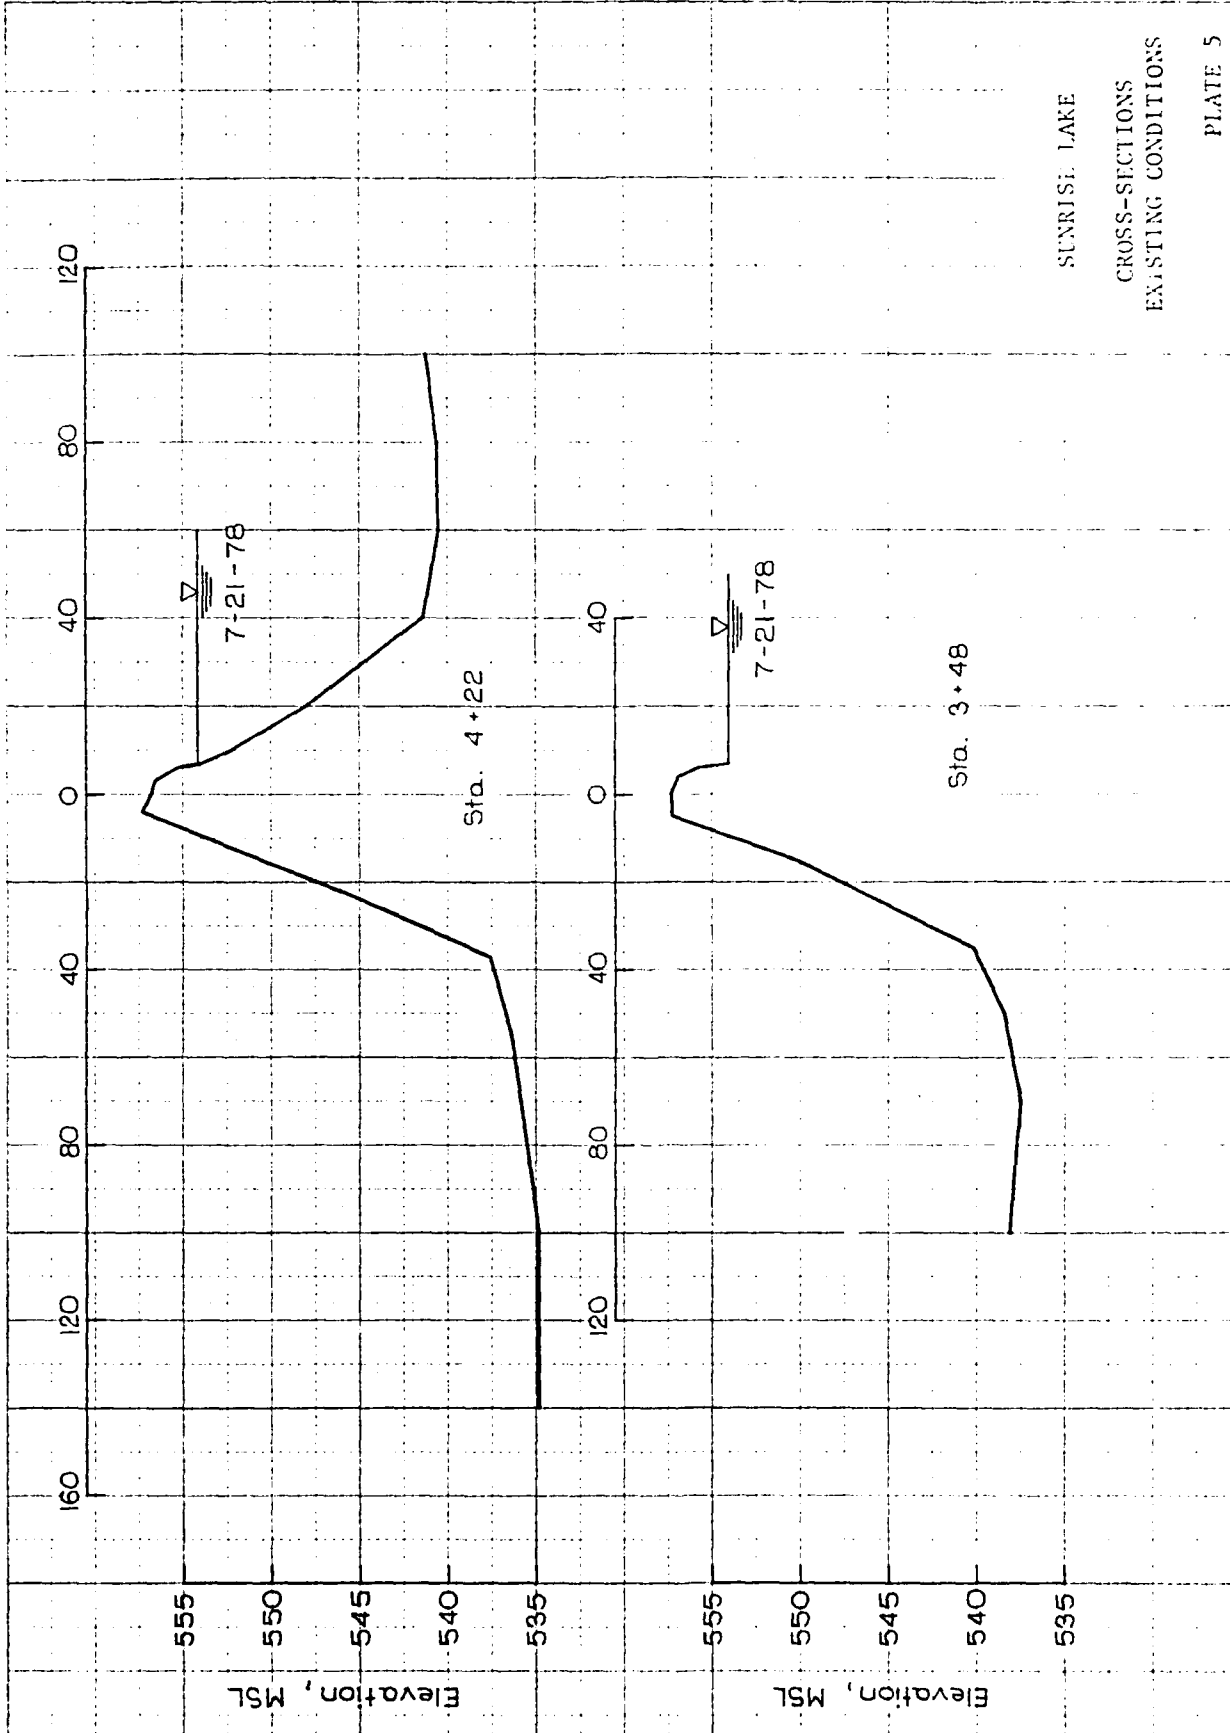
SUNRISE LAKE
 CROSS-SECTIONS
 EXISTING CONDITIONS
 PLATE 5

Based on the cross-sections presented on Plates 4 and 5, the upstream embankment has an average slope of 1V on 2.5H. The downstream embankment slope is very steep (1V on 1.5H average slope) as shown on Plates 4 and 5 (see Photos 5 and 6). A 20-foot wide, area of saturation is located on the downstream embankment slope at baseline station 4+22 (see Photos 7 and 8). The area begins at elevation 546 feet m.s.l. on the slope and continues downslope to the toe (elevation 537.6 feet m.s.l.). The area is soft and percolates a small quantity of water.

b. Perform seepage and stability analyses to assess the safety concerns raised by the observed seepage, the saturated area on the downstream slope, and the steep downstream slope. Use the results of these analyses to design appropriate corrective measures.
